MEMORANDUM

Project: Gold King Interim Water Treatment Plant (IWTP)

Reporting Period: Aug 15 – Aug 22

Report No.: 33

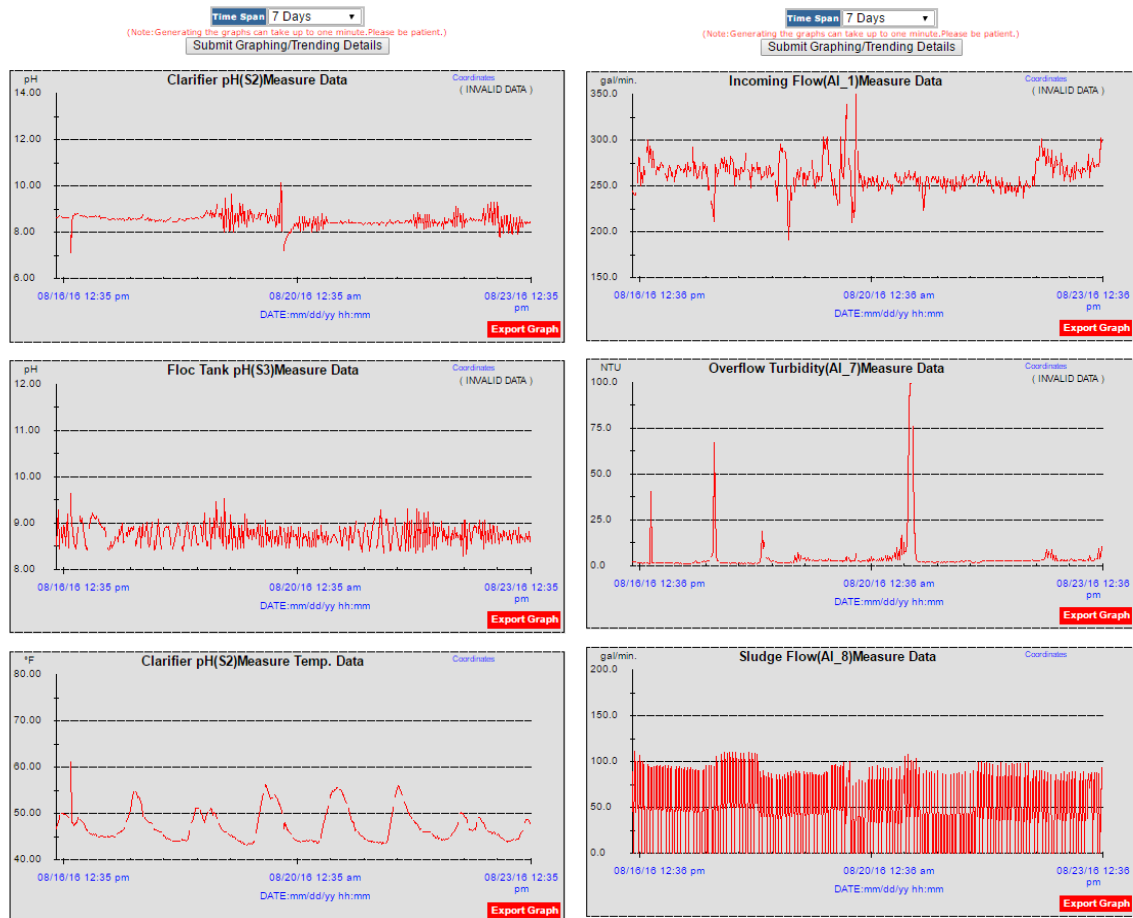
- The following graphs provide trending information during the previous 7 days. The dataloggers collect control information from the Lime Circuit (left) and Flow Circuit (right) Programmable Logic Controllers (PLCs) at the Gold King IWTP. Over the reporting period (8/15/16 – 8/22/2016 inclusive) Alexco treated 5.97 million gallons at an average flow rate of 592 gpm.

- Please note: Several days each week, the Alexco operators check the pH at both the flocc tank and clarifier discharge. During this time, the probe is placed in vinegar (acid), and three pH buffers – 4, 7, and 10. While the probe is in the acid/buffer, the datalogger may capture one of those points for tracking purposes, which explains the occasional pH spikes seen on the graph. In addition, instantaneous spikes of the Overflow Turbidity Meter are associated with routine cleaning, which can cause the meter to spike temporarily up to 100 NTUs.
